## Case Studies in Engineering Failure Analysis

## Failure analysis of edge discoloration of galvanized fuel tank

R&amp;D and Scientific Services, Tata Steel Ltd., Jamshedpur 831001, India

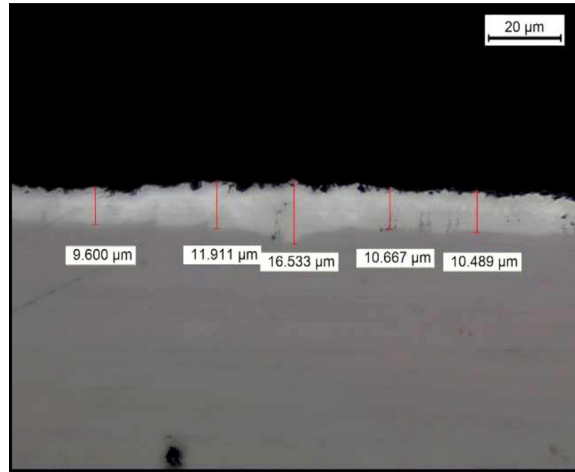
Fig. 2. Optical microphotograph of the top surface of Galvanized fuel tank.

is shown in Fig. 2; whereas bottom surface is shown in Fig. 3. Uniform coating is observed on top surface with an average thickness of 11.84  $\mu\text{m}$ ; whereas bottom coating appeared as brittle in nature. Average coating thickness at bottom surface was 10.58  $\mu\text{m}$ . Coating thickness of top surface having bright appearance is more than the coating of bottom surface.

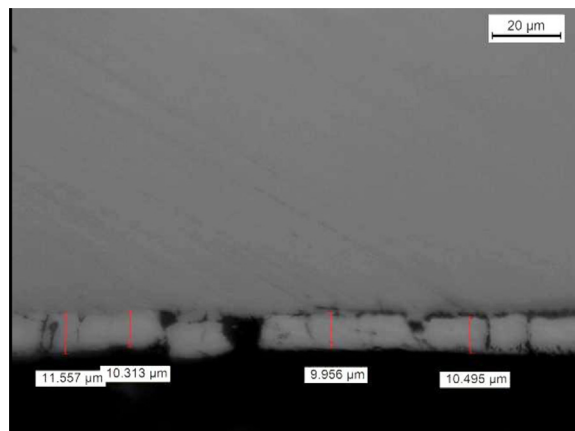
Fig. 3. Optical microphotograph of the bottom surface of Galvanized fuel tank.

Based on the preliminary results, the following hypothesis was made: The dull appearance of the bottom surface is due to the partial Galvannealing (GA) formation. The metallographic analysis shows the partial GA formation on both bottom and top surfaces though the extent of GA formation is greater on the bottom surface due to which the appearance is darker as compare to top surface. The complaint coil was processed during galvanizing to galvannealing transition when the zinc bath aluminium run down was going on. There was thickness and width transition and the coil was processed at a lower line speed on account of its thicker section.

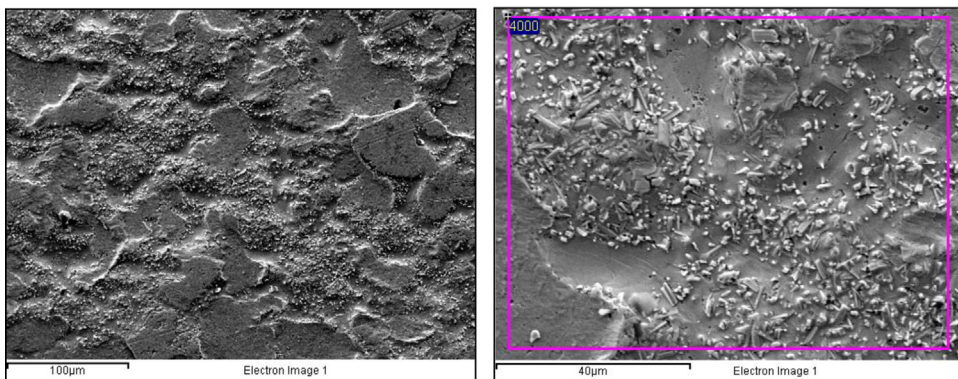
The SEM microphotograph from the defect region, having grain structure like appearance on the galvanized fuel tank is shown in Fig. 5a. Fig. 5a shows two distinct regions, viz. Region A is the partially zeta crystals, region B is the skin pass marks. Fig. 5b is the high magnification SEM micrograph of region A and B in Fig. 5a. From Fig. 5b we can see that the zeta crystals are partially appeared over the surface indicating transition zone of Galvannealing and Galvanizing at this region. EDS analysis was carried out at this transition region showing the concentration in wt.% of Zn, Fe and Al in these regions as mentioned in Table 2.

**Fig. 5.** (a) SEM Microphotograph of transition region of Galvannealing and Galvanizing at 1000 $\times$  magnification. (b) High magnification (4000 $\times$ ) SEM microphotograph of transition region.

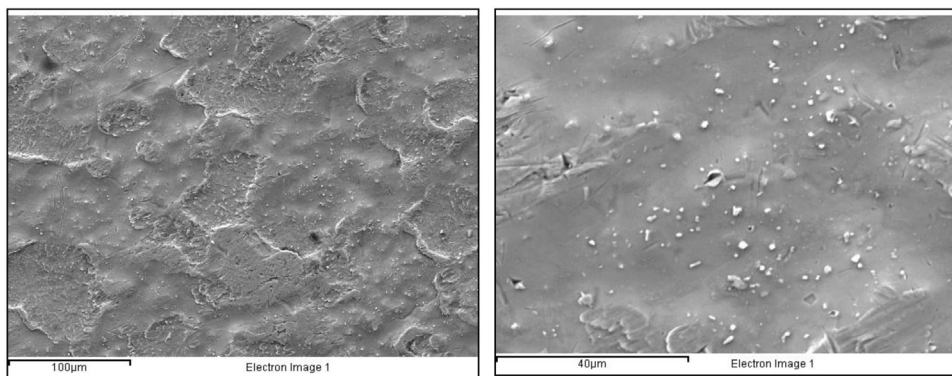
The SEM microphotograph from the non-defect region having bright appearance shows Galvanized surface appearance along with skin pass mark as shown in Fig. 6a. Fig. 6b is the high magnification SEM microphotograph of Galvanized surface. EDS analysis was carried out at this bright region showing the concentration in wt.% of Zn, Fe and Al in these regions as mentioned in Table 3.

Fig. 6. (a) SEM microphotograph of Galvanized surface at 1000 $\times$  magnification. (b) High magnification (4000 $\times$ ) SEM microphotograph of Galvanized surface.
